# Navajo Abandoned Uranium Mine Site Screen Report

## Section 36

### Navajo AUM Eastern Region

**May 2009**

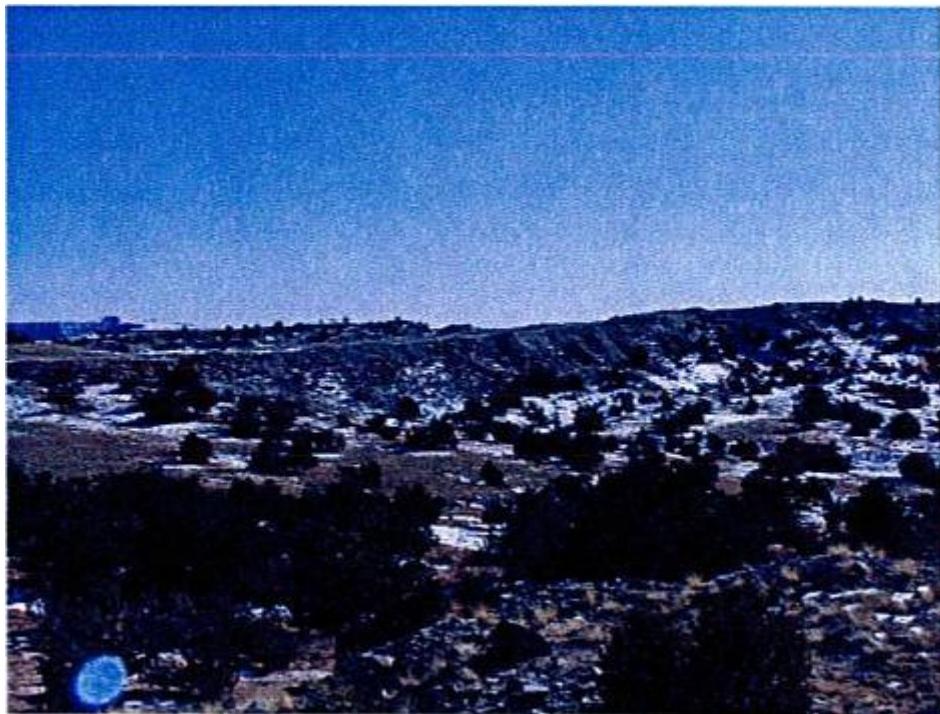
**The following photos were collected during a 2008 field survey for the New Mexico Mining and Minerals Division:**

View north, piles and cut

View north, piles, cut, access road

View east at primary disturbance

Overall view
